4. TITLE (and Subtitle) National Program of Inspection of Non-Federal Dams, Tennessee. Colonial Country Club-16th Hole Dam (Inventory Number TN 15774) near Memphis, Tennessee, Shelby County, TN. Wolf River Basin		5. TYPE OF REPORT & PERIOD COVERED Phase I Investigation Report

PHASE I INSPECTION  
COLONIAL COUNTRY CLUB 16th HOLE DAM  
SHELBY COUNTY, TENNESSEE

PHASE I INSPECTION REPORT  
NATIONAL DAM SAFETY PROGRAM  
TENNESSEE

Name of Dam Colonial Country Club - 16th Hole  
County Shelby  
Stream Tributary Fletcher Creek  
Date of Inspection April 2, 1981

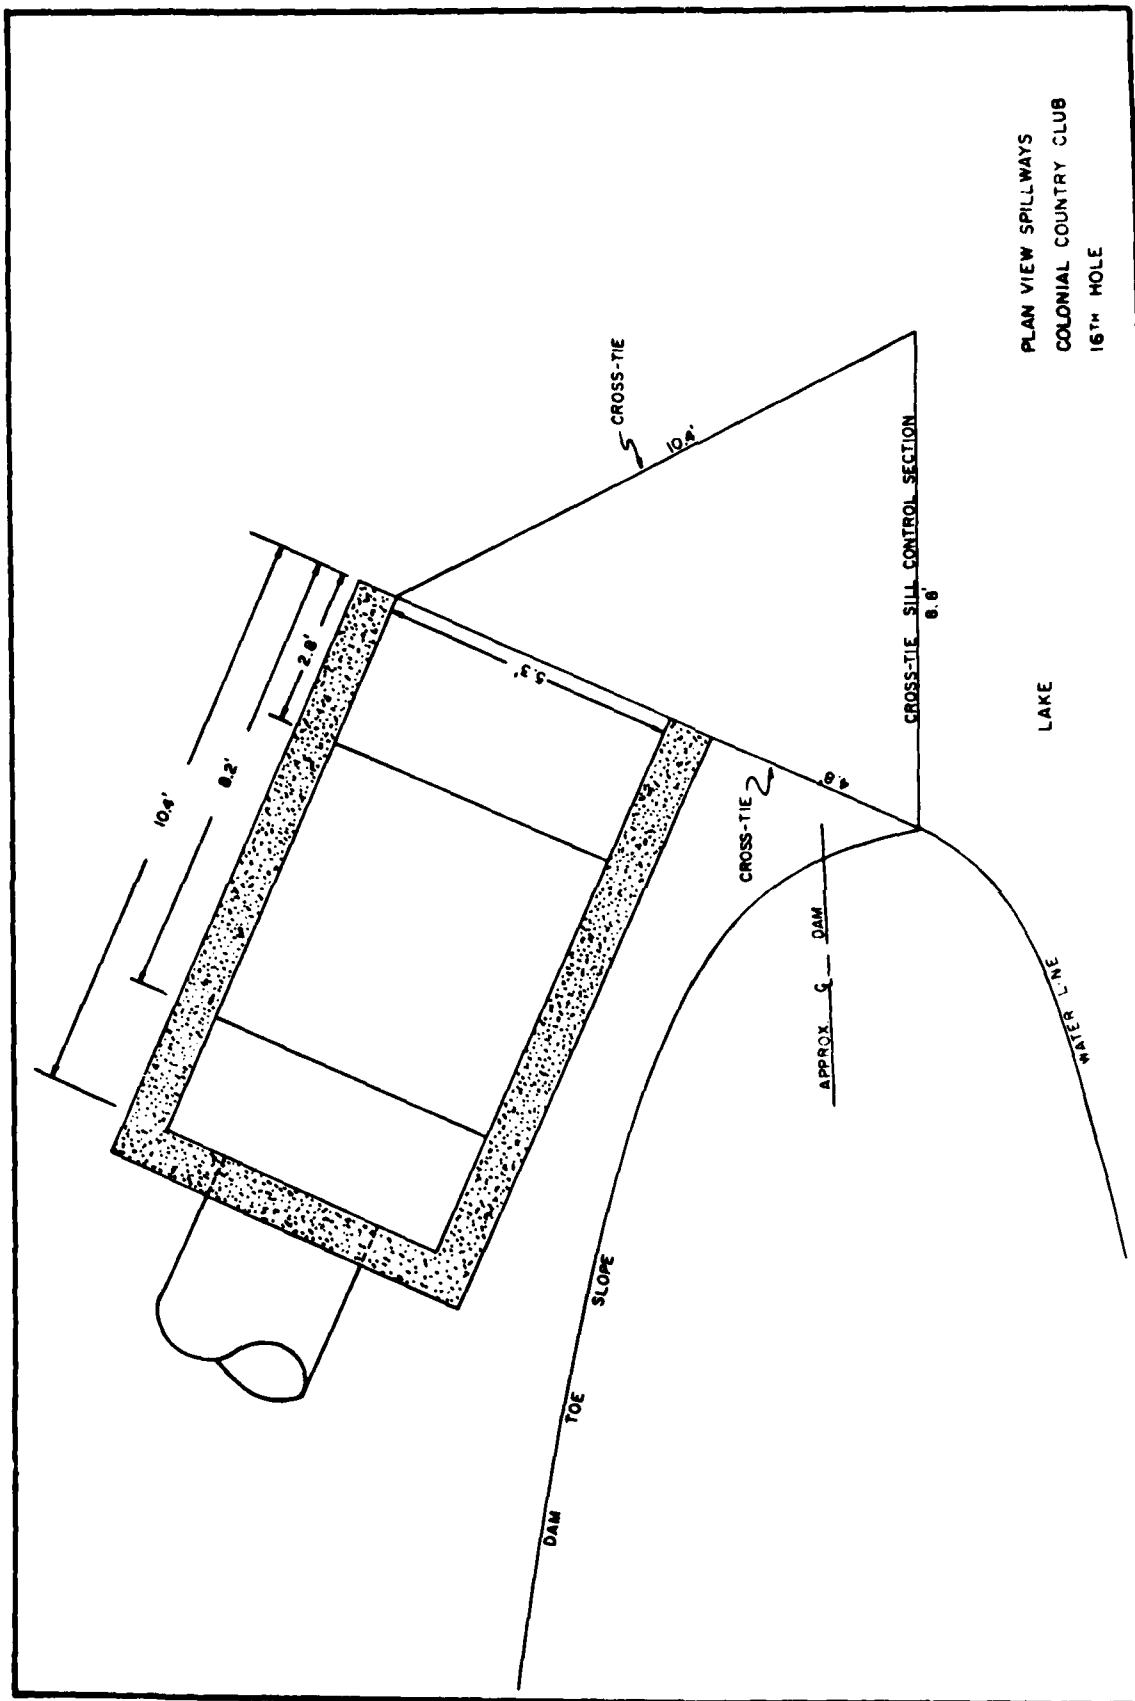
PLAN VIEW SPILLWAYS  
 COLONIAL COUNTRY CLUB  
 16TH HOLE

2.2.3 Emergency Spillway - The emergency spillway is located in the west abutment and has a concrete control section approximately ten feet long with the abutment side slope of 1:6 and the dam side slope of 1:6. The emergency spillway has a flat section approximately 50 feet in length, which includes the service spillway located as noted above. The weir of the service spillway is located approximately 0.2 feet below the control section elevation. It is estimated that the service spillway carries 50% of the maximum flow of the emergency spillway. Excess water is carried in a swale located between the toe of the dam and the foundations of two houses.
